CHIMNEY STACK · NORTH EAST ENGLAND

# Eyes at the top, feet on the ground

Close range drone inspection of a failing chimney stack capping for a national commercial roofing contractor, with no MEWP, no scaffold and nobody working at height.

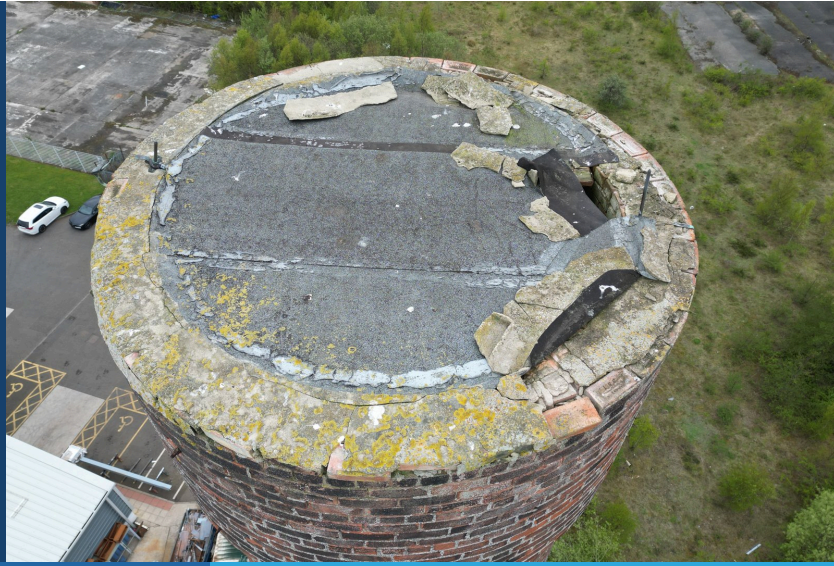
- Cracked, displaced and missing coping units, with sections lifting at the edge
- Torn cap covering, with loose debris sitting on top of the stack
- Heavy lichen and open joints letting water into the head of the stack
- Weathered pointing and spalled bricks recorded down the shaft
